REPORT NO: SY-139R-77
AIRTASK NO: A5345341/0532/7534000001
WORK UNIT NO: A53411-20
DATE: 13 July 1977

COPY NO. 45 **NAVAL AIR TEST CENTER**
REPORT OF TEST RESULTS

Test and Evaluation of AH-1T Forward Ground Handling Gear Assembly (P/N 209-052-244-1);
Second Report (Final)

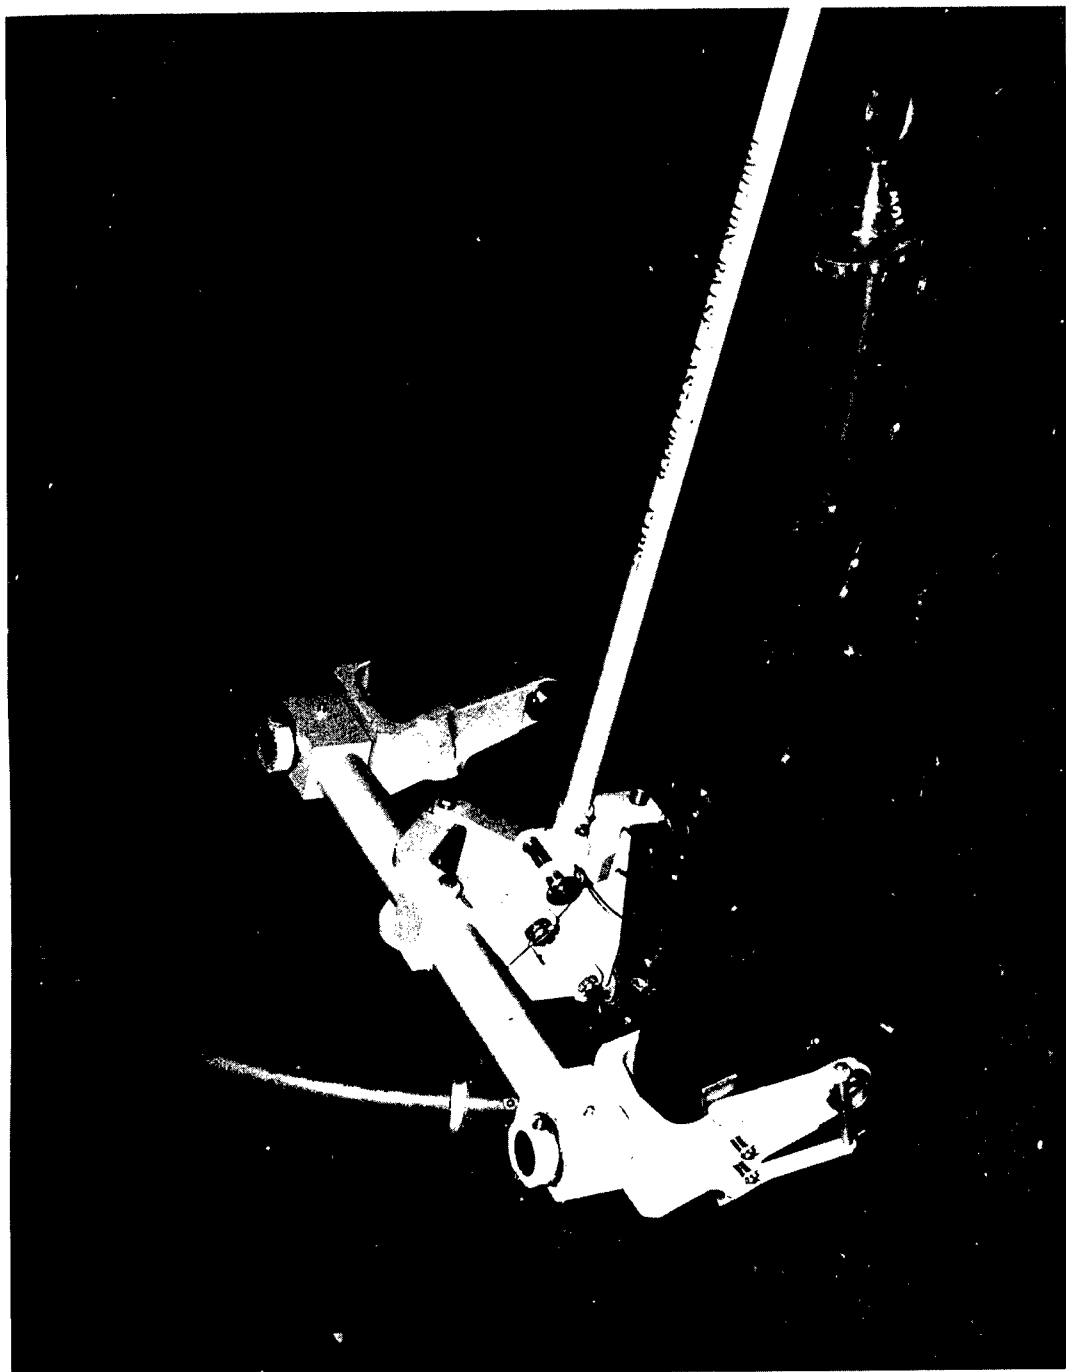
3. The Forward Ground Handling Gear Assembly (enclosure (1), figure 1) consists of two full castoring wheels connected by a common trunnion with a lift mechanism and a 36 in. (91.4 cm) lever handle. The Gear Assembly is attached to two lugs on the forward portion of each skid by means of a solid pin which engages the rear lug and a quick release pin that engages the front lug in the aircraft skid. The lever handle must be held straight up in a vertical position while installing the Gear Assembly, then rotated forward and down to the horizontal position to raise the front portion of the aircraft skid.

Figure 1
Forward Ground Handling Gear Assembly (P/N 209-052-244-1)

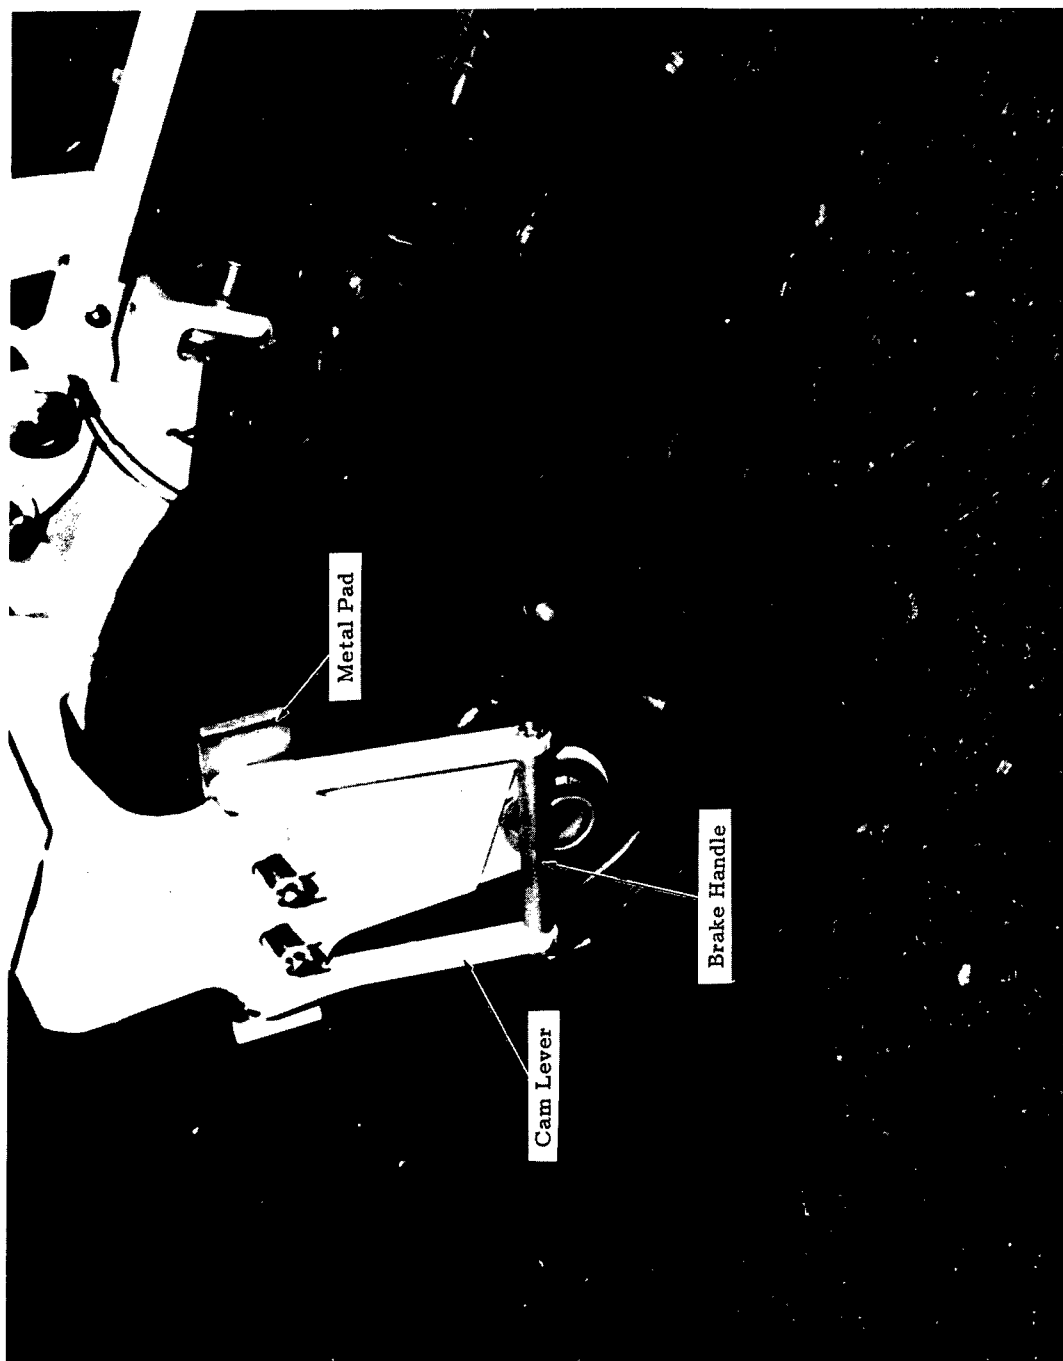
5. The means of stopping tire rotation are inadequate. The brake assembly consists of a cam-lever that contacts a metal pad which then presses against only one side of the pneumatic tire (enclosure (1), figure 2). Applying pressure to only one side of the tire causes tire deflection but does not prevent tire rotation. In addition, there is only one brake on each Gear Assembly which is located on the side of a caster housing. When the aircraft is being moved in one direction, the brake assembly is outboard of the tire. However, when the direction is reversed, the castered wheel rotates 180 deg placing the brake assembly on the inboard side of the tire. This type of brake assembly will result in maintenance personnel not being able to stop the aircraft in an emergency situation. The inadequate means of stopping tire rotation is a Part I deficiency which must be corrected as soon as possible.

14. Inadequate means of stopping tire rotation (paragraph 5).

Figure 2
Brake Assembly

21. Correct the Part I deficiencies cited in paragraphs 13 through 16 as soon as possible.

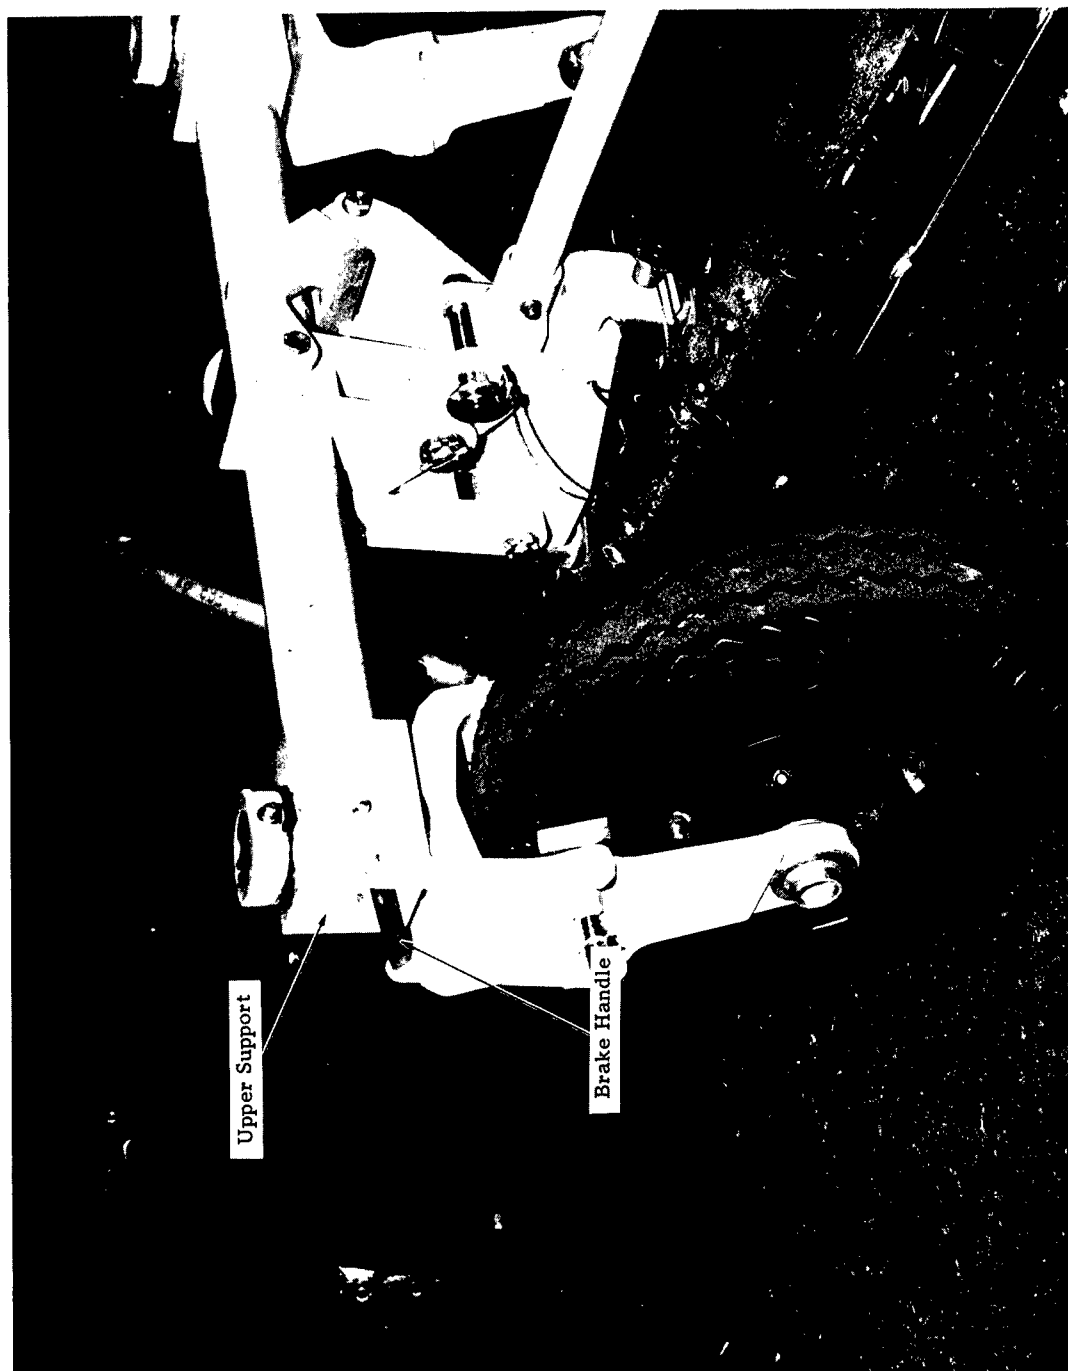
6. There is a lack of provisions to prevent the brake assembly handle from being rotated 180 deg through the horizontal position. While the brake is off, the handle is in a vertical down position (enclosure (1), figure 2). To engage the brake, the handle must be pulled up to a horizontal position. Continuing to pull the handle up over center will place it in a vertical up position and will disengage the brake. In the up position, the handle will rest against the upper support of the wheel assembly (enclosure (1) figure 3). Maintenance personnel applying the brake and

failing to stop at the horizontal position will have their hand trapped between the brake handle and upper support of the Gear Assembly. Failure to provide a stop that will prevent the handle from being rotated through the horizontal position will result in a potential safety hazard to maintenance personnel. The lack of provisions to prevent the brake assembly handle from being rotated 180 deg through the horizontal position is a Part I deficiency which must be corrected as soon as possible.

15. Lack of provisions to prevent the brake assembly handle from being rotated 180 deg through the horizontal position (paragraph 6).

Figure 3
Interference Between Brake Handle and Upper Support

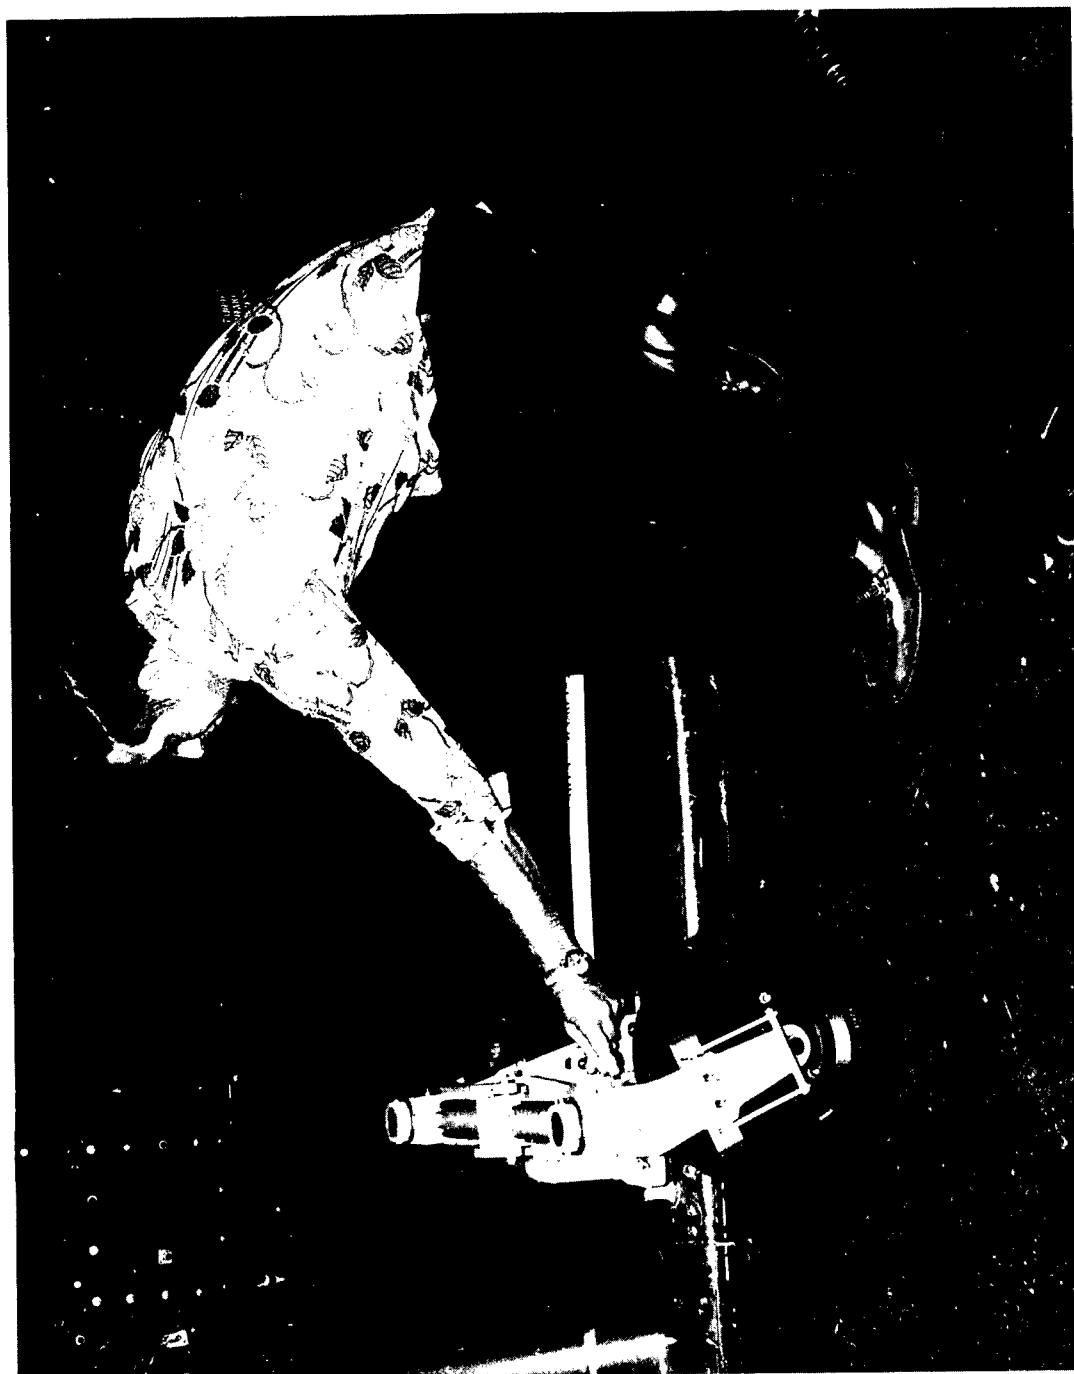
9. The length of the wire rope assemblies that secure the two quick release pins to the Gear Assembly is excessive. One quick release pin is used for securing the Gear Assembly to the aircraft skid front lug and the other quick release pin is used for securing the lever handle in the down position (enclosure (1), figure 6). These pins are different lengths and if interchanged will not function satisfactorily. The length of the wire rope assemblies allow either pin to be used for either application which results in a "MURPHY" situation. Also, the quick release pin could be damaged as a result of being caught under the skid while lowering the aircraft. The excessive length of the wire rope assemblies constitutes a Part II deficiency which should be corrected as soon as practicable.

18. Excessive length of quick release pin wire rope assemblies (paragraph 9).

Figure 5
Inserting Quick Release Pin in Gear Assembly Housing

22. Correct the Part II deficiencies cited in paragraphs 17 through 19 as soon as practicable.

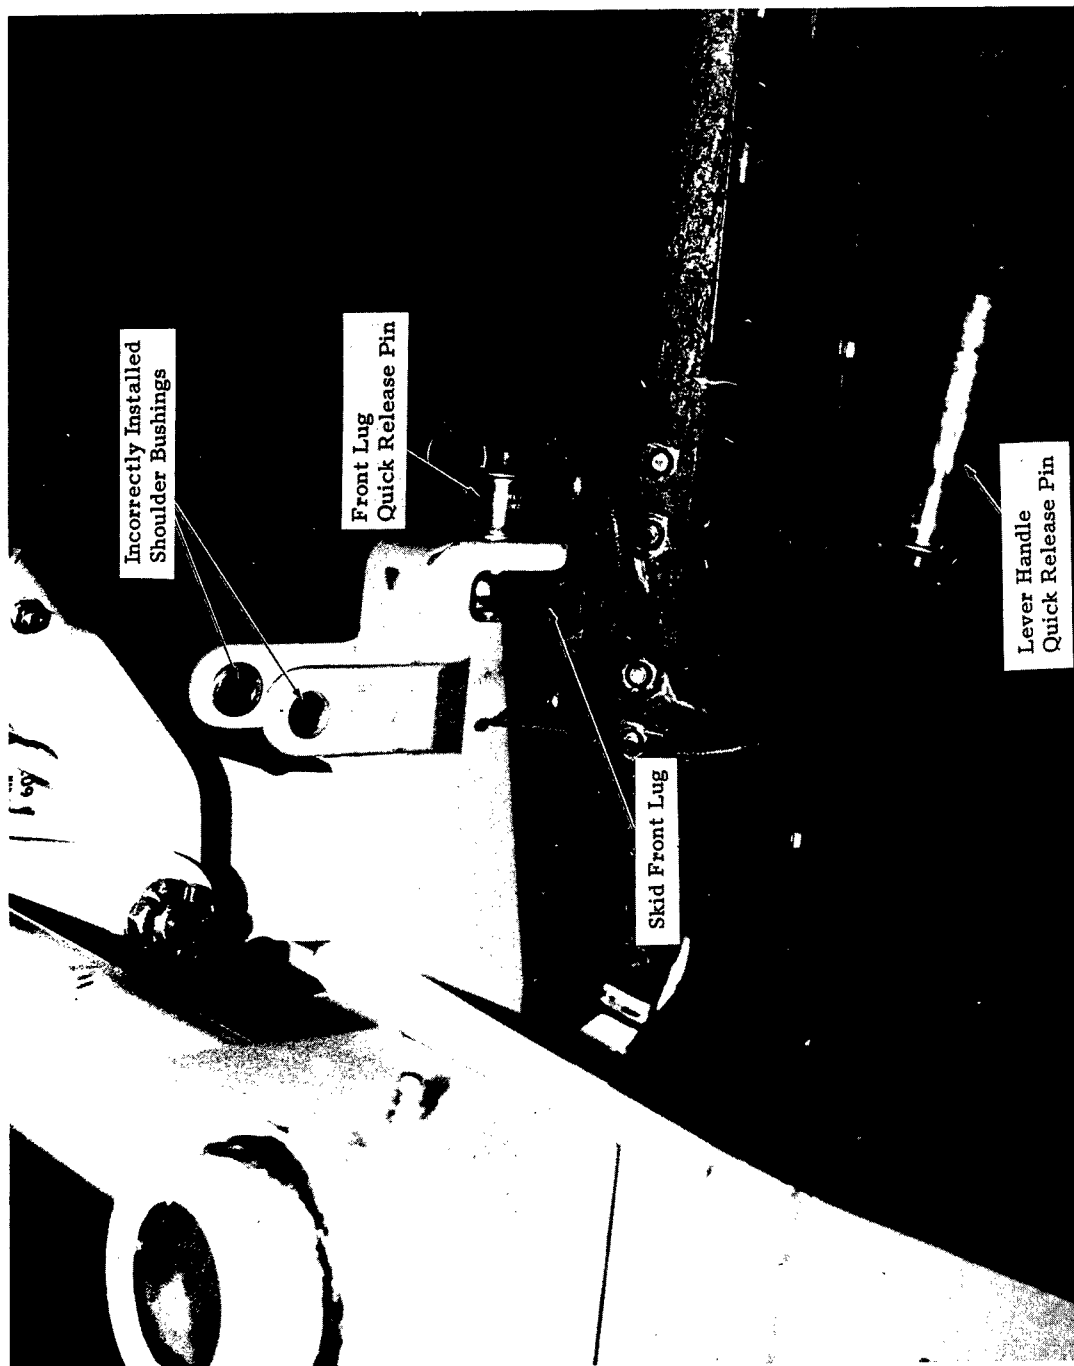
10. There is a lack of support for both ends of quick release pin. The forward attachment point for securing the Gear Assembly to the aircraft skid (enclosure (1), figure 6) consists of a bushed hole in the gear housing. A quick release pin is inserted through the bushed hole and a hole in the aircraft skid front lug. The aircraft weight is exerted on the quick release pin which is not supported at both ends and results in a bending moment being applied to the quick release pin. Failure to support the quick release pin at both ends so that a shear load is applied to the pin will cause excessive bushing wear and pin deformation which will result in the inability to secure the wheel assembly to the aircraft. The lack of support for both ends of the quick release pin is a Part II deficiency which should be corrected as soon as practicable.

19. Lack of support for both ends of the forward attachment point quick release pin (paragraph 10).

Figure 6
Quick Release Pin Housing
